GROSS DAMAGE REPORT

Subject: (6) [Director] Ship [Material] [Gross] Damage Report [A-1, (Test  
ABLE re-entry plus five (5) days report.)] [43.60]

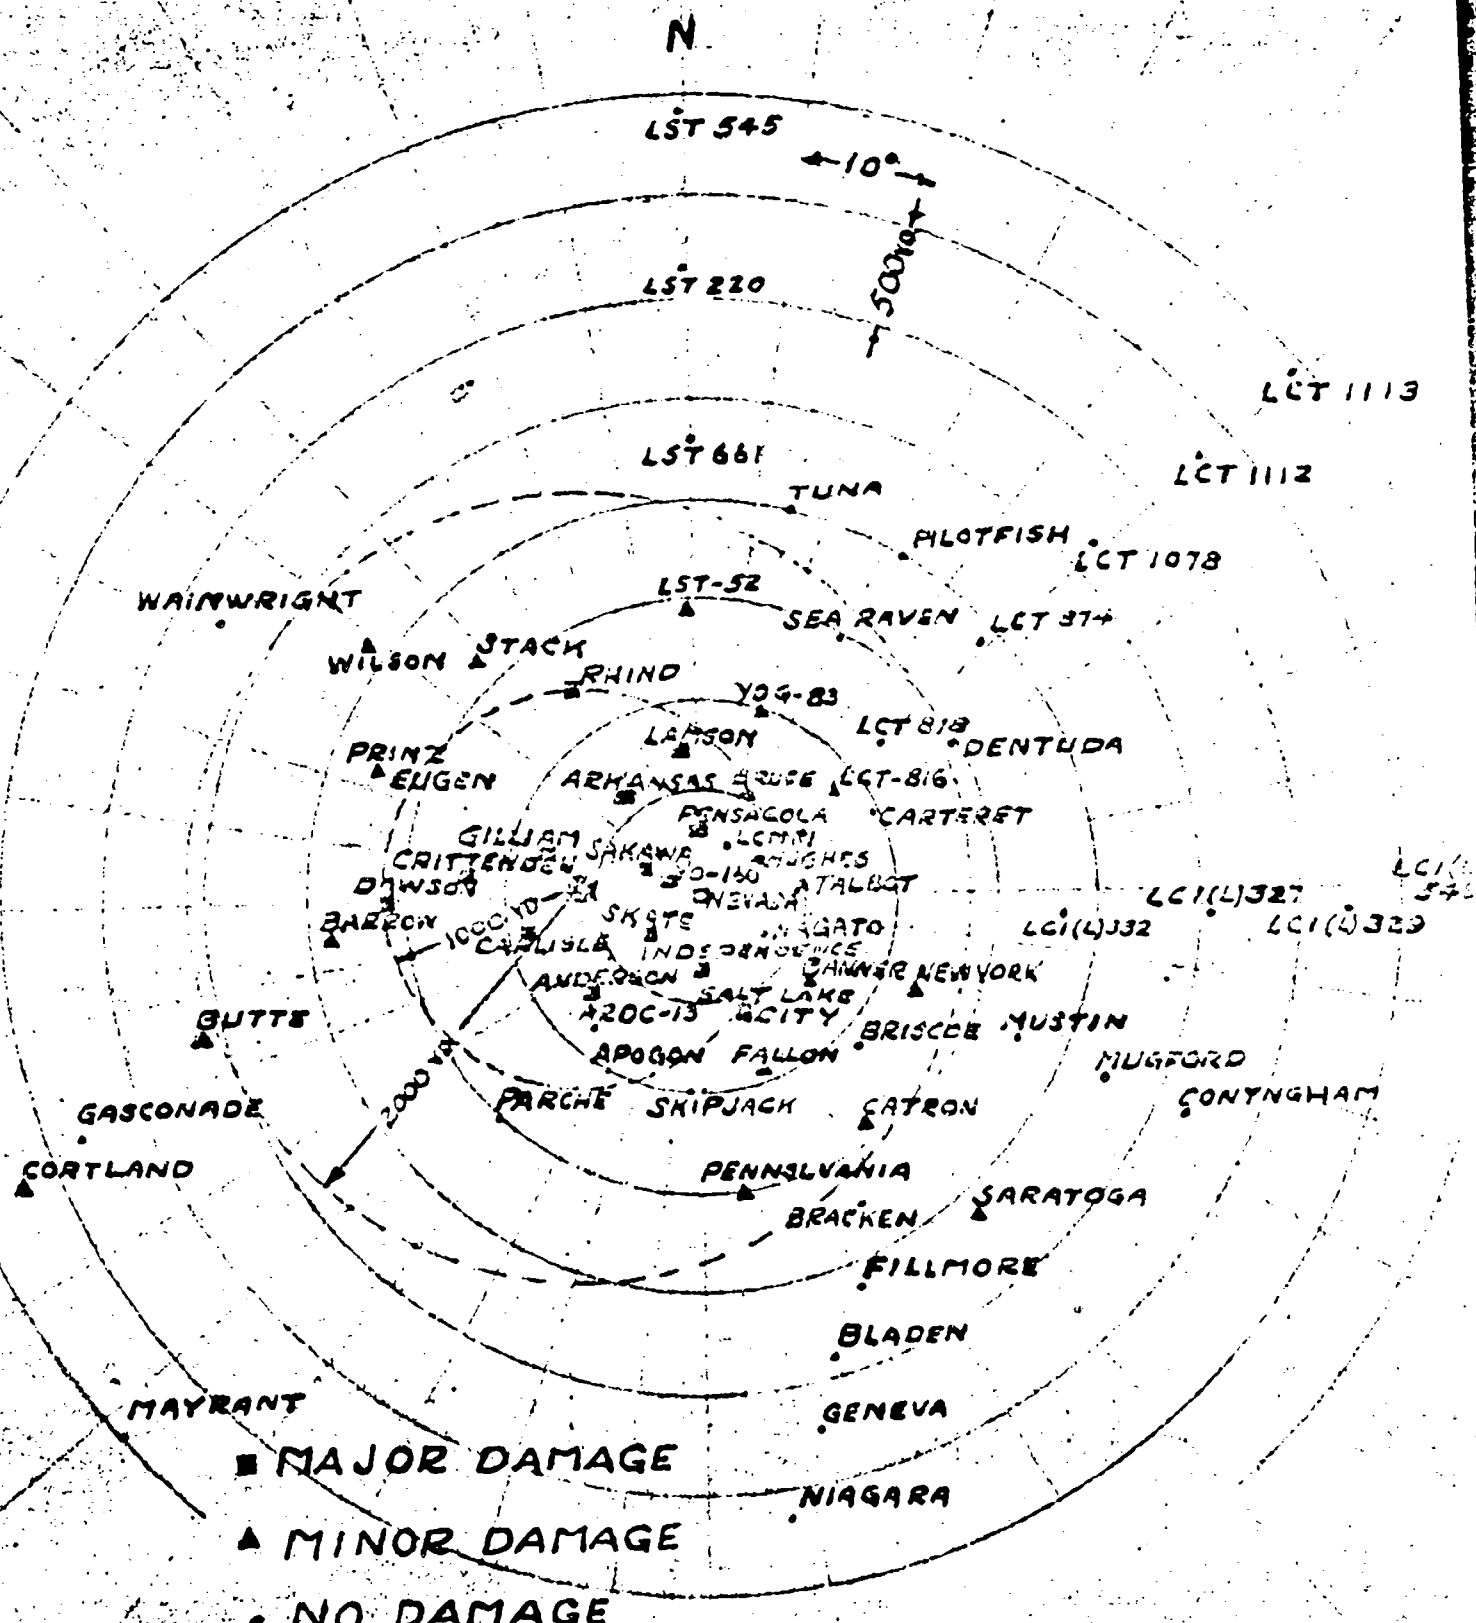
**TARGET SHIP ARRAY WITH  
SUMMARY OF ELECTRONIC  
DAMAGE**

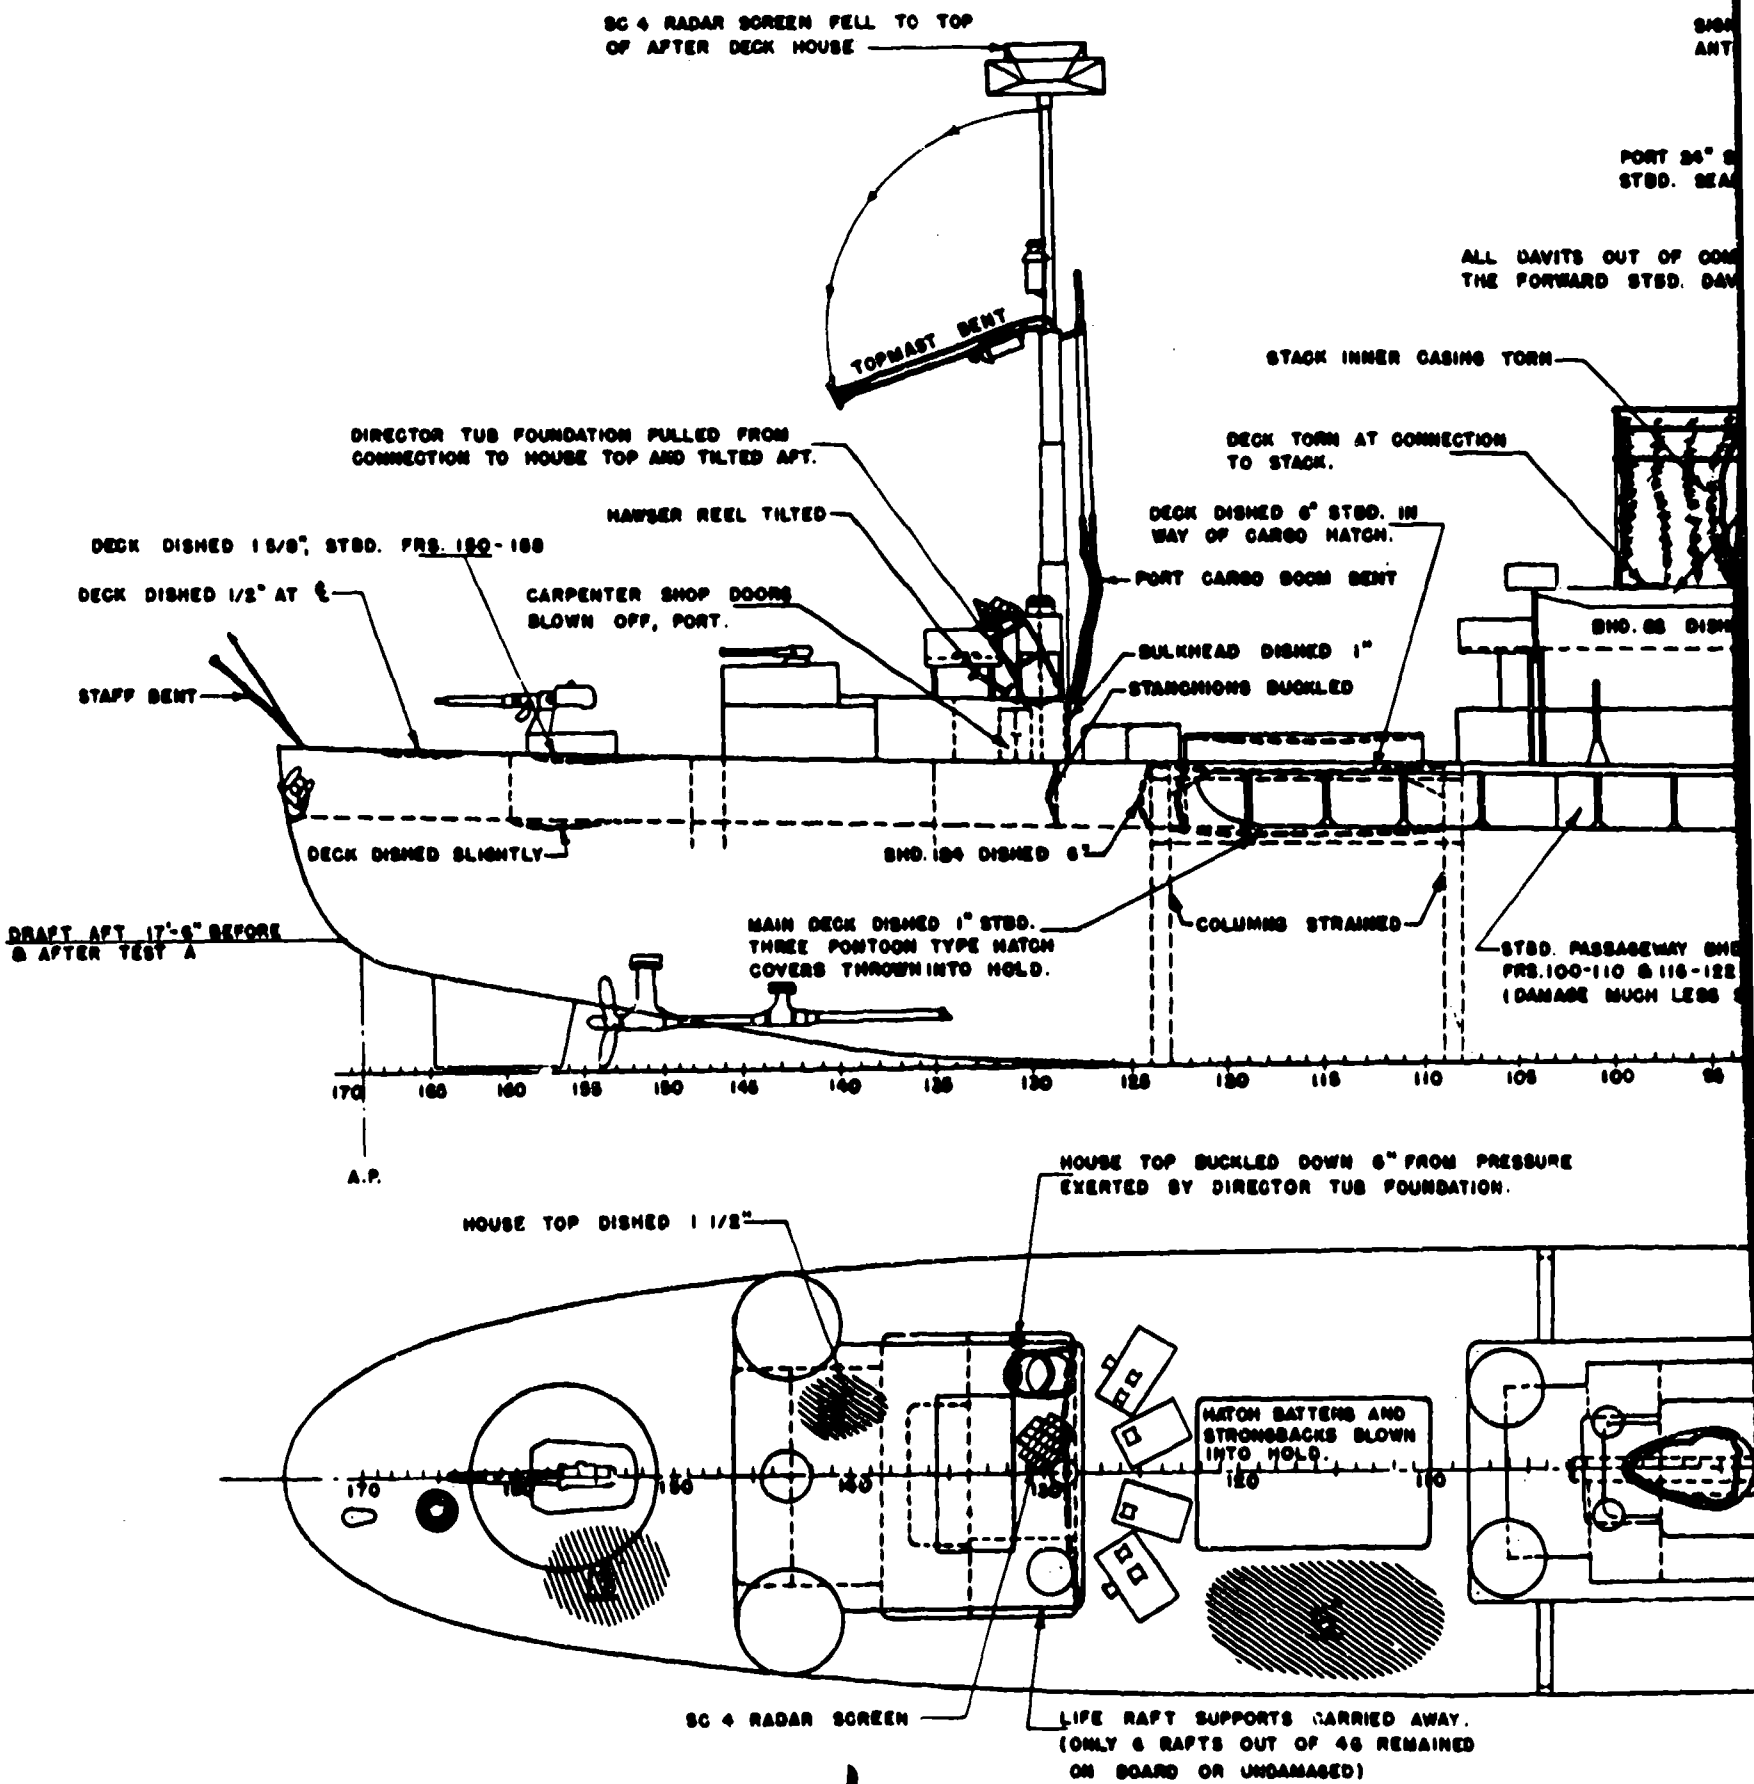
LIFE RAFT SUPPORTS CARRIED AWAY.  
(ONLY 6 RAFTS OUT OF 48 REMAINED  
ON BOARD OR UNDAAGED)

SIGNAL MAST BENT, YARD ARMS DAMAGED,  
ANTENNAE AND MASTYARDS DOWN.

PORT 24" SEARCHLIGHT BLOWN OFF AND  
STBD. SEARCHLIGHT DEMOLISHED.

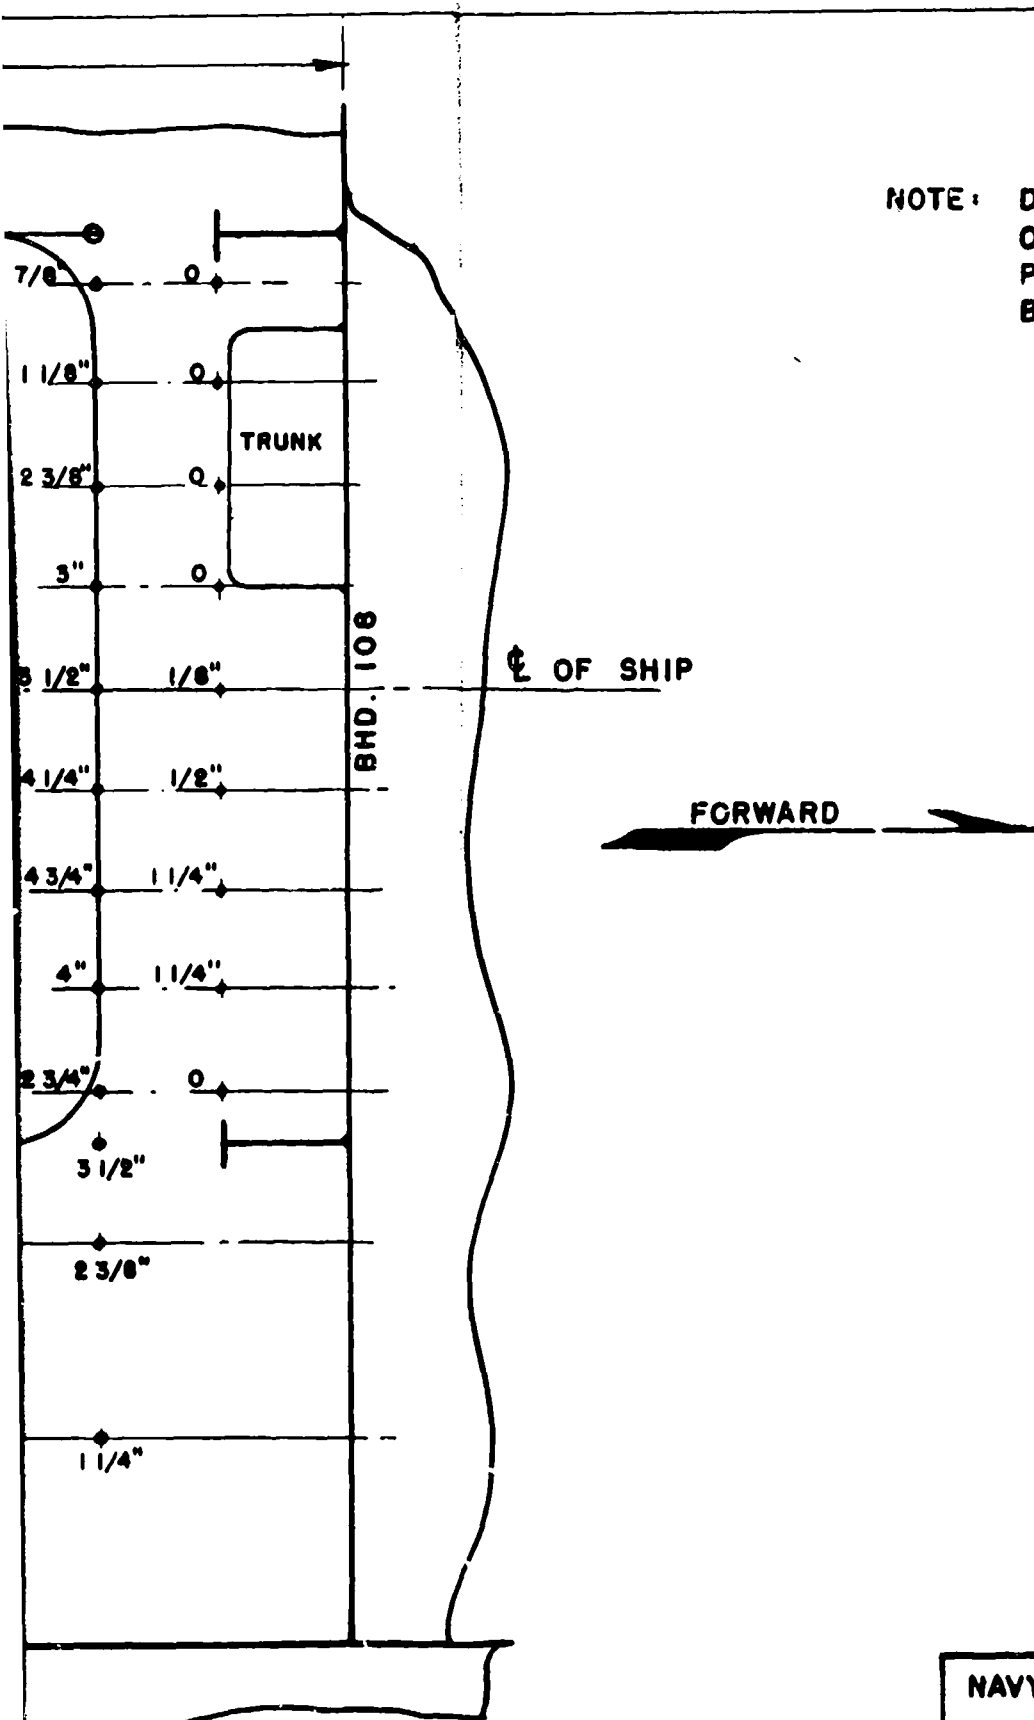
NOTE: DECK DEFLECTION MEASUREMENTS  
OBTAINED BY MEASURING TO DECK  
PLATE FROM CHALK LINE STRETCHED  
BETWEEN BHDS. 108 AND 124.
